# 3D printed MPGDs

- 3 samples finally arrived last week
- Produced at different temperatures
- Pure ceramic without copper plane
- Aim: Check holes and HV stability

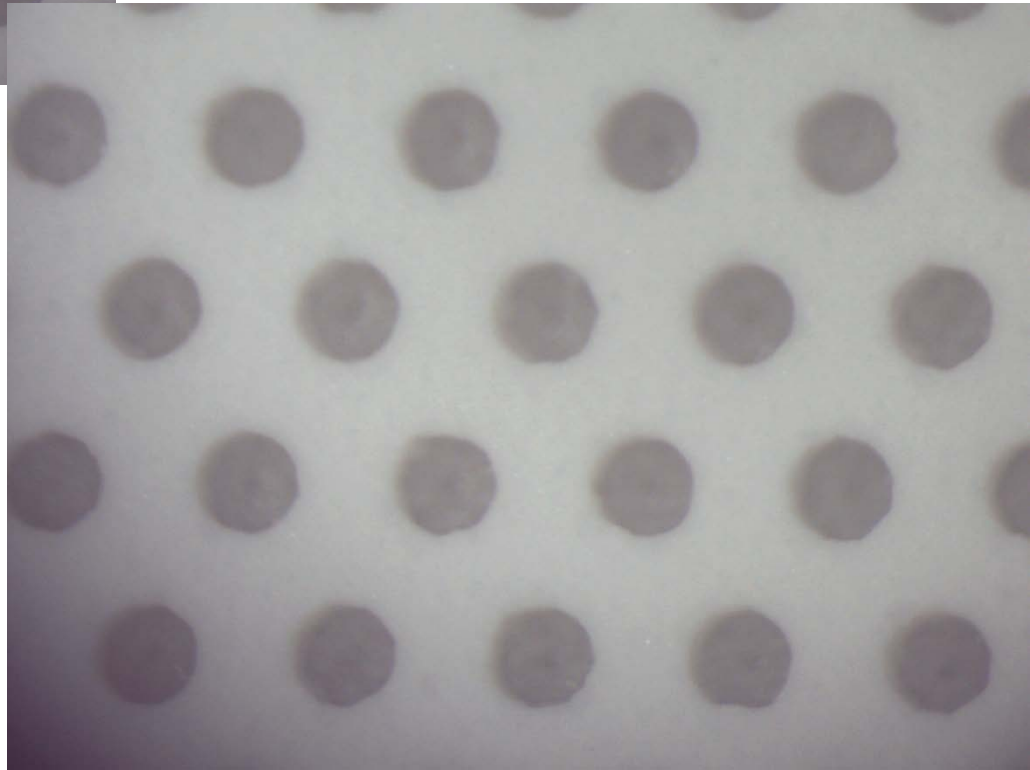
First scan with microscope  
with wide angle

- large differences between the 2 sides of the samples
- from the production problem seem to be in one side
- difference between sides depends on sample

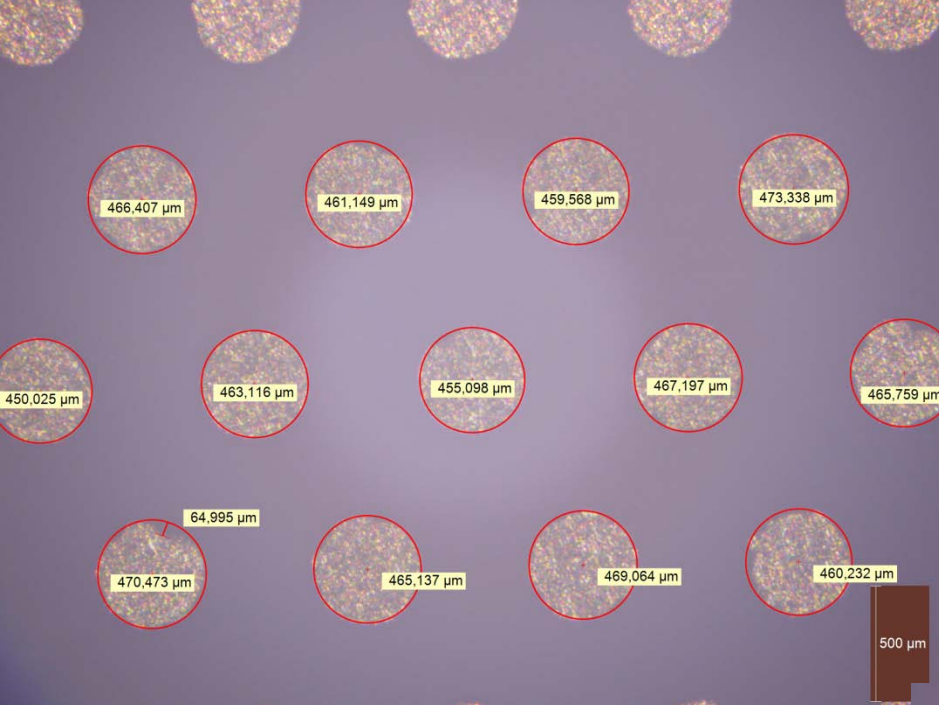
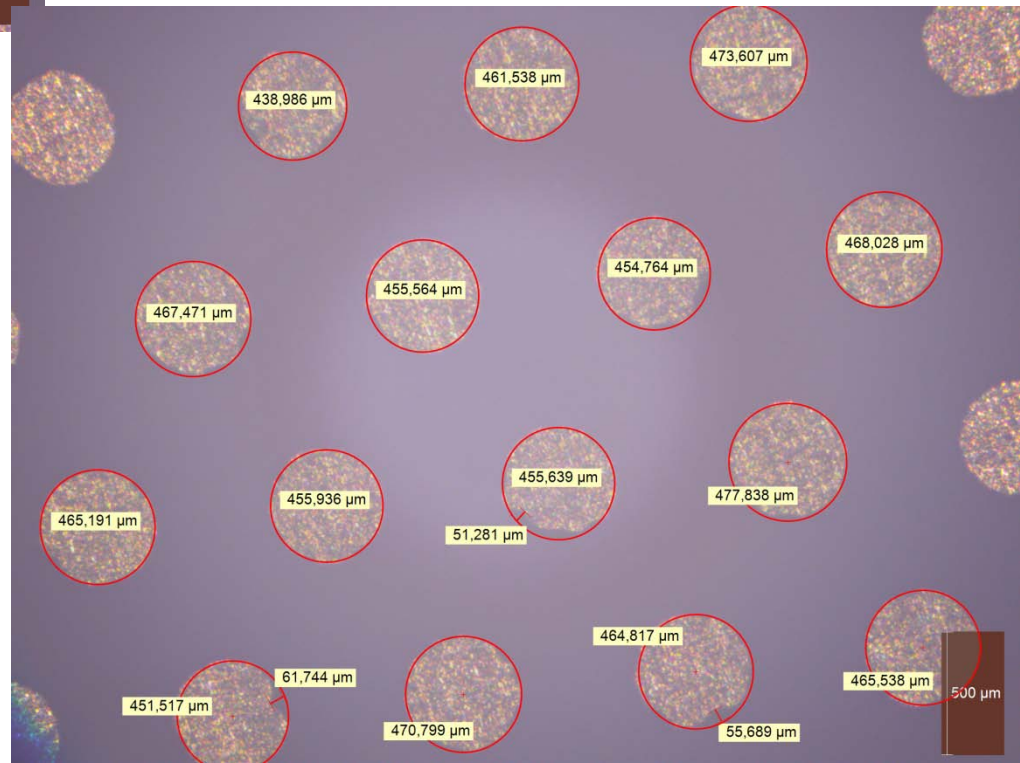
## Second microscope with measurement possibility

- measurement not so easy sometimes due to non-uniform holes
- nominal diameter seems to be 470  $\mu\text{m}$  (to be checked with Dresden)
- mean and error still to be calculated
- some deformations of up to 60  $\mu\text{m}$  in some holes
- thickness: 570  $\mu\text{m}$  (to be checked with Dresden)

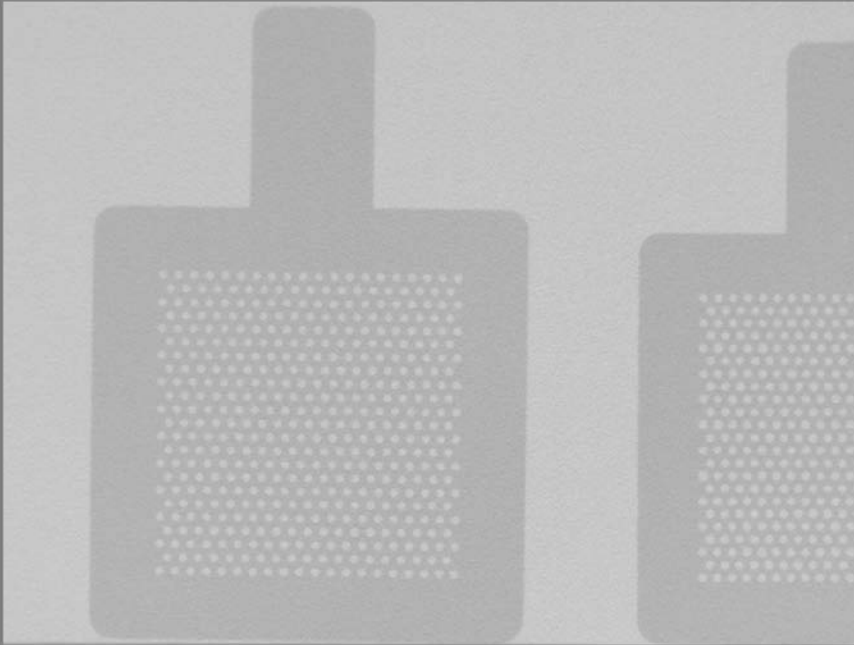
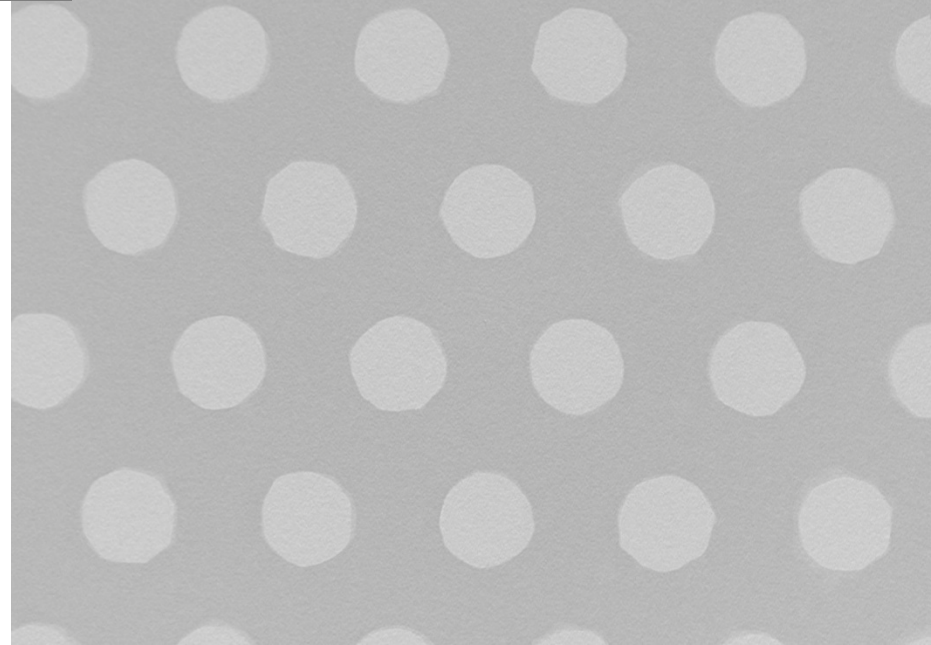
X-ray device to look for cracks and non-uniformities in density

- density looks very homogenous
- very few tiny variations were seen with zoom
- holes also not perfectly round with X-rays but seem to be more uniform than with light => hole deformations mainly at the edges of the holes? Could the sides be polished to remove these?

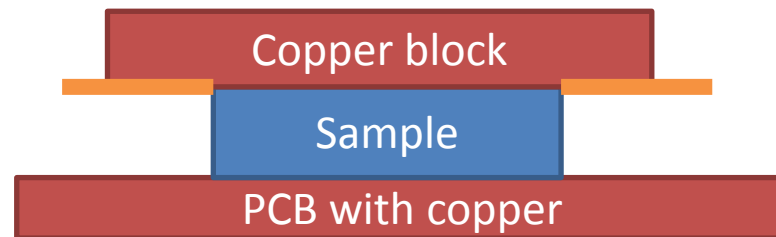
- HV tested in gas detector with dry air (some one stole my N2)
- not optimal configuration: electrodes should be smaller than sample and better sample without holes
- first 2 samples sparking at 2-2.8 kV but sparks seem through air at the edges of the copper block
- last sample with longer time under air flow before HV test started stable for 40 hours at 3 kV and now without current at 3200 V
