# 3D printed MPGDs

- 3 samples finally arrived last week
- Produced at different temperatures
- Pure ceramic without copper plane
- Aim: Check holes and HV stability

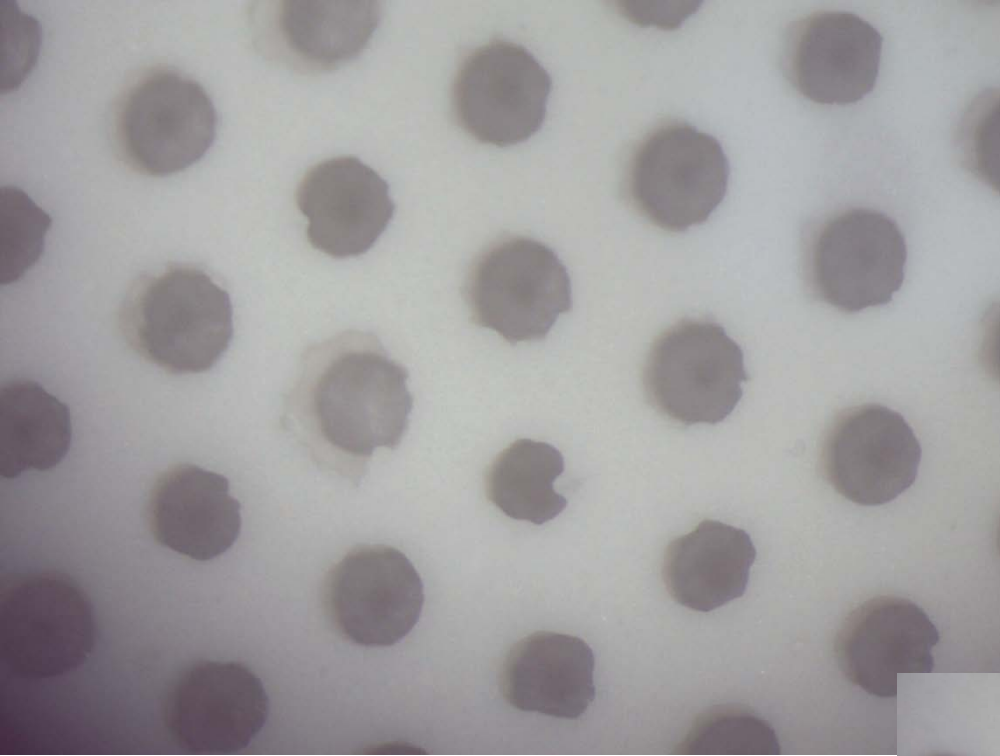
First scan with microscope  
with wide angle

- large differences between the 2 sides of the samples
- from the production problem seem to be in one side
- difference between sides depends on sample
